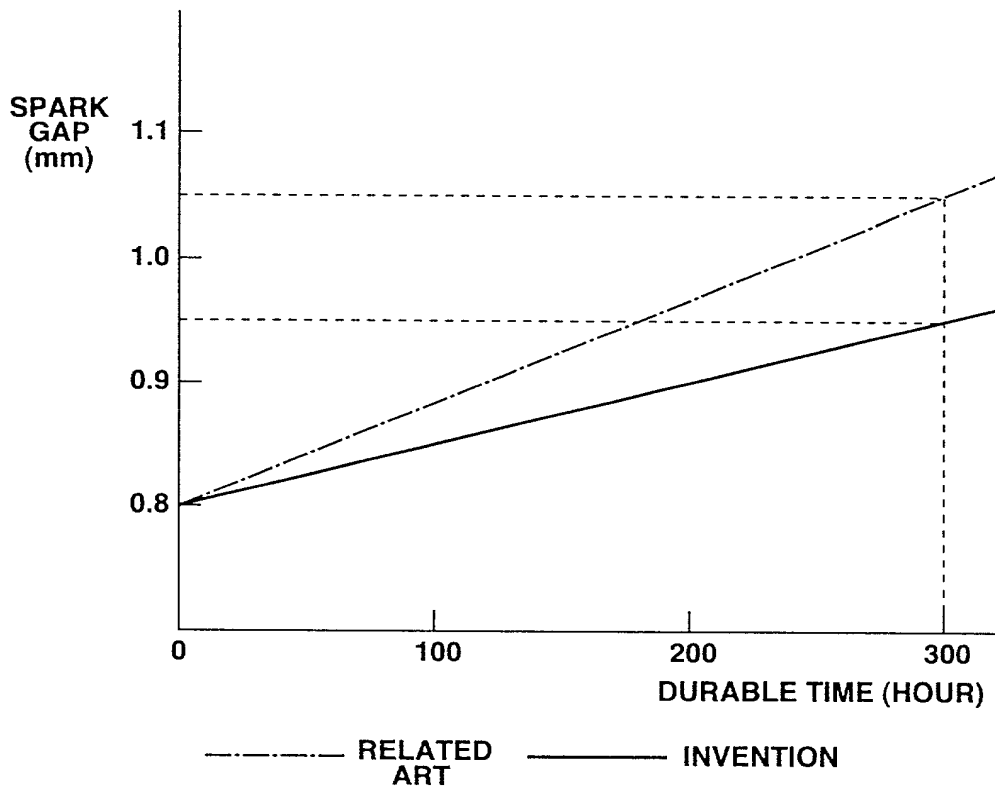
FIG.4

DURABILITY TEST RESULT
